# Exhaust Valve Borescope Inspections

(What to look for, and how to interpret what you see.)

by Dean Showalter, A&P / IA  
Commercial pilot and CFI  
[AirplaneOwnerMaintenance.com](http://AirplaneOwnerMaintenance.com)  
April 20, 2019

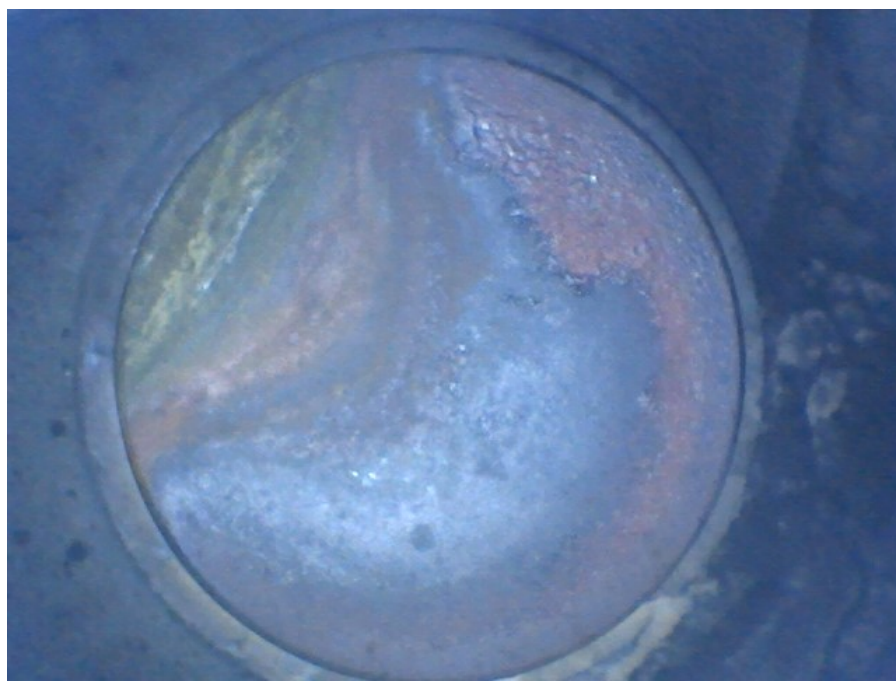
The previous picture is what I saw with the borescope in cylinder #6 during the annual inspection. The upper left side shows signs of significant burning, indicated by the greenish color. Burning means when the valve is closed, it does not seat well against the valve seat, which allows very hot exhaust gases to “leak” and flow around the edge of the valve. This burning effect is like a torch that burns the normal deposits off the surface of the valve. If the whole surface was like what we see from 2 o’clock to 8 o’clock, this valve would be just fine. But the greenish edge is a real problem, and we removed this cylinder for repair.

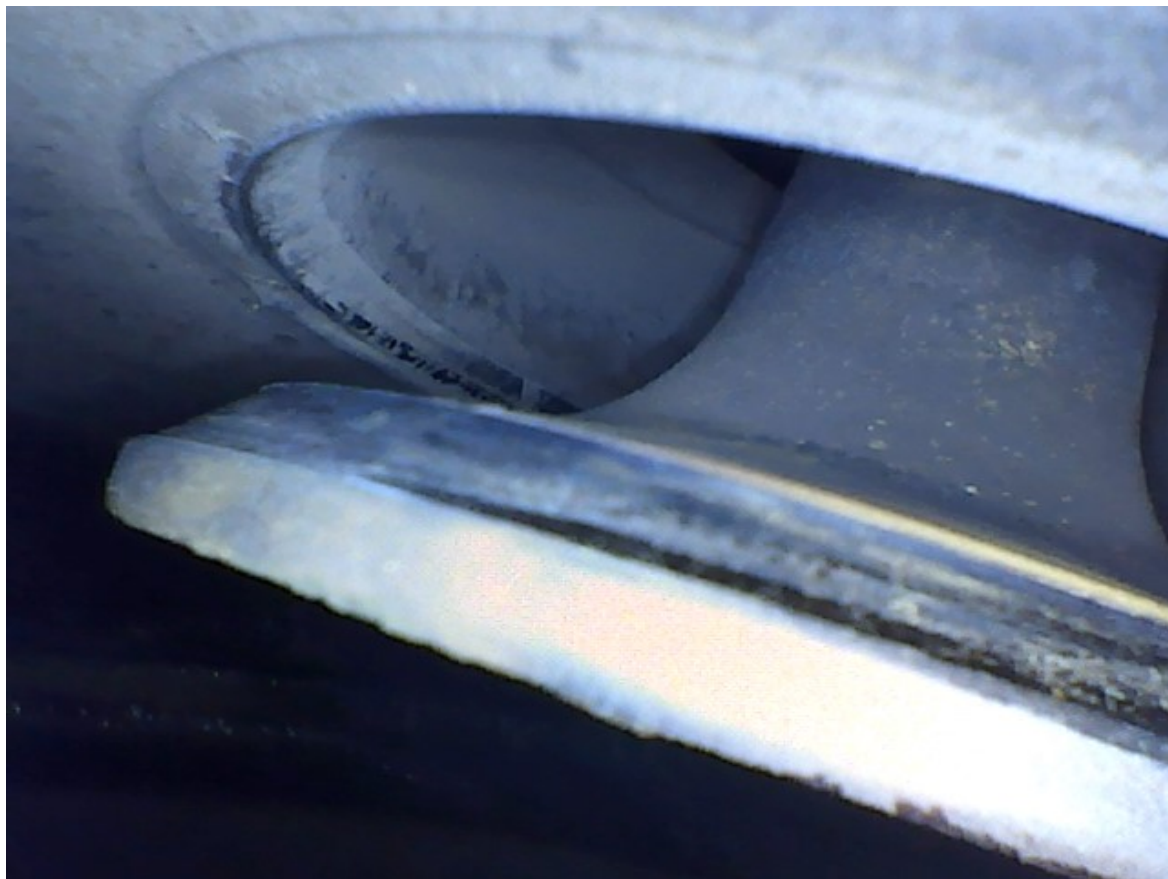
Although the structure of the valve still looked quite good, the seating area shows evidence of a poor seal, indicated by the hazy surfaces. A good seal will usually show a shiny, much wider band, both on the valve and the seat. Healthy valves have a

shiny band that is approximately 1/16 to 1/8 inch wide. However, I have also been amazed at how “rough” valves and seats can look, and still produce a compression test in the 70”s.

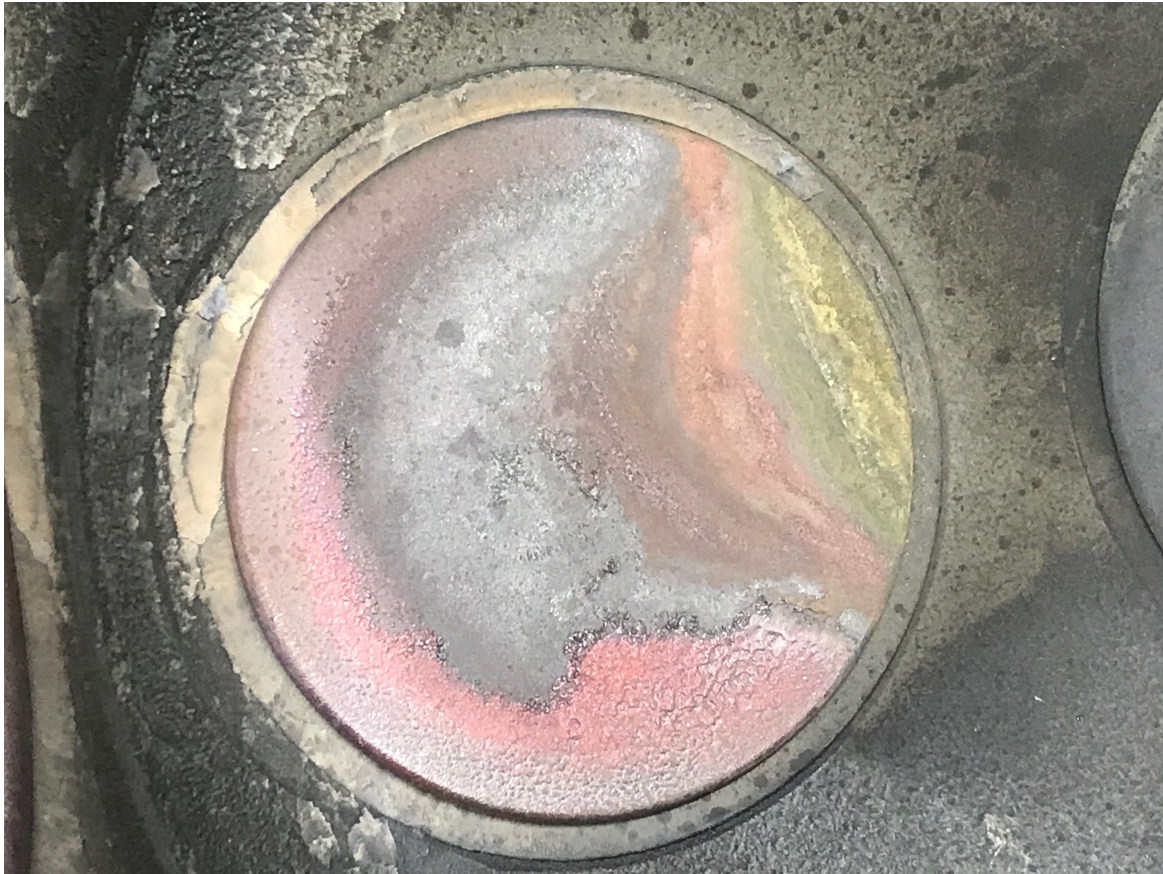
After removing cylinder #6:

Here's the same exhaust valve, from a different angle after removing the cylinder. This one needed to go!

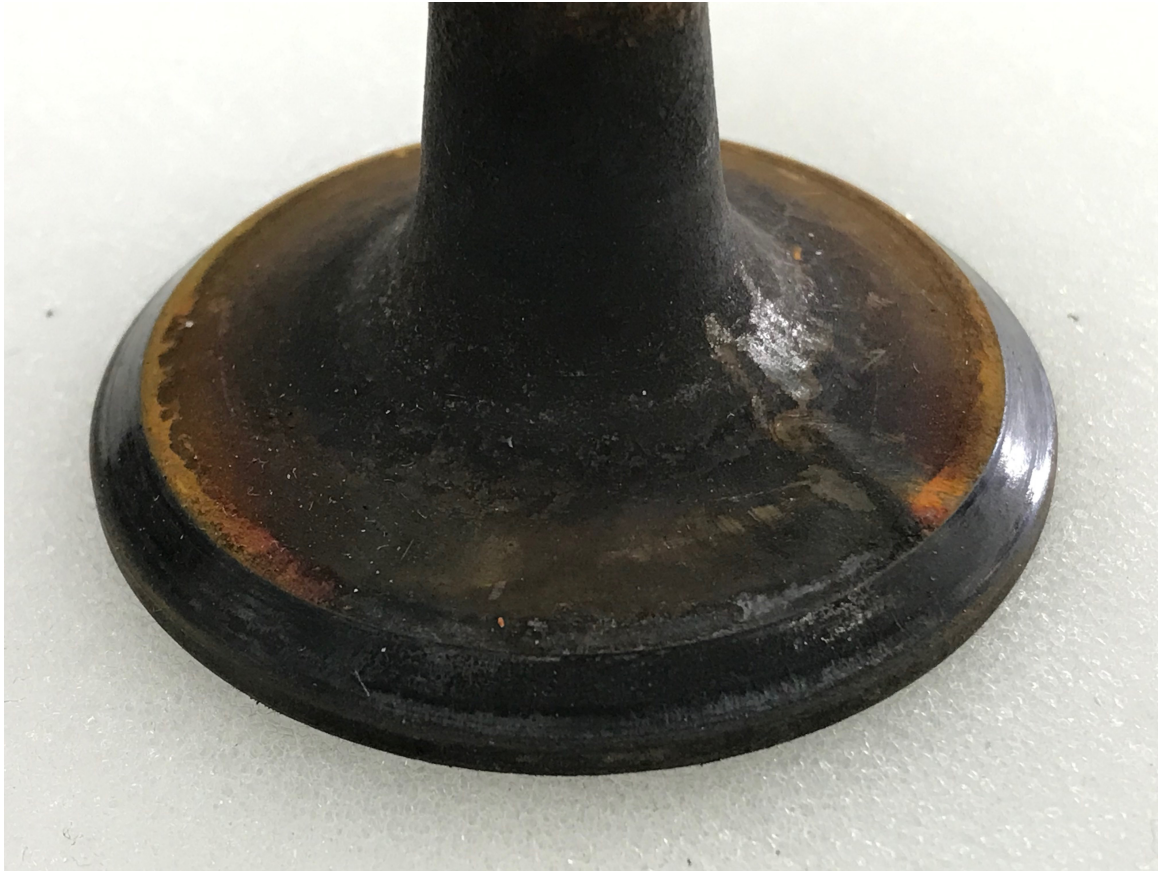
In the previous picture, notice the edge on this side that looks rough and inconsistent. If we tipped the valve up to look at the other side, we would see the green edge where the hot spot and burning was happening.

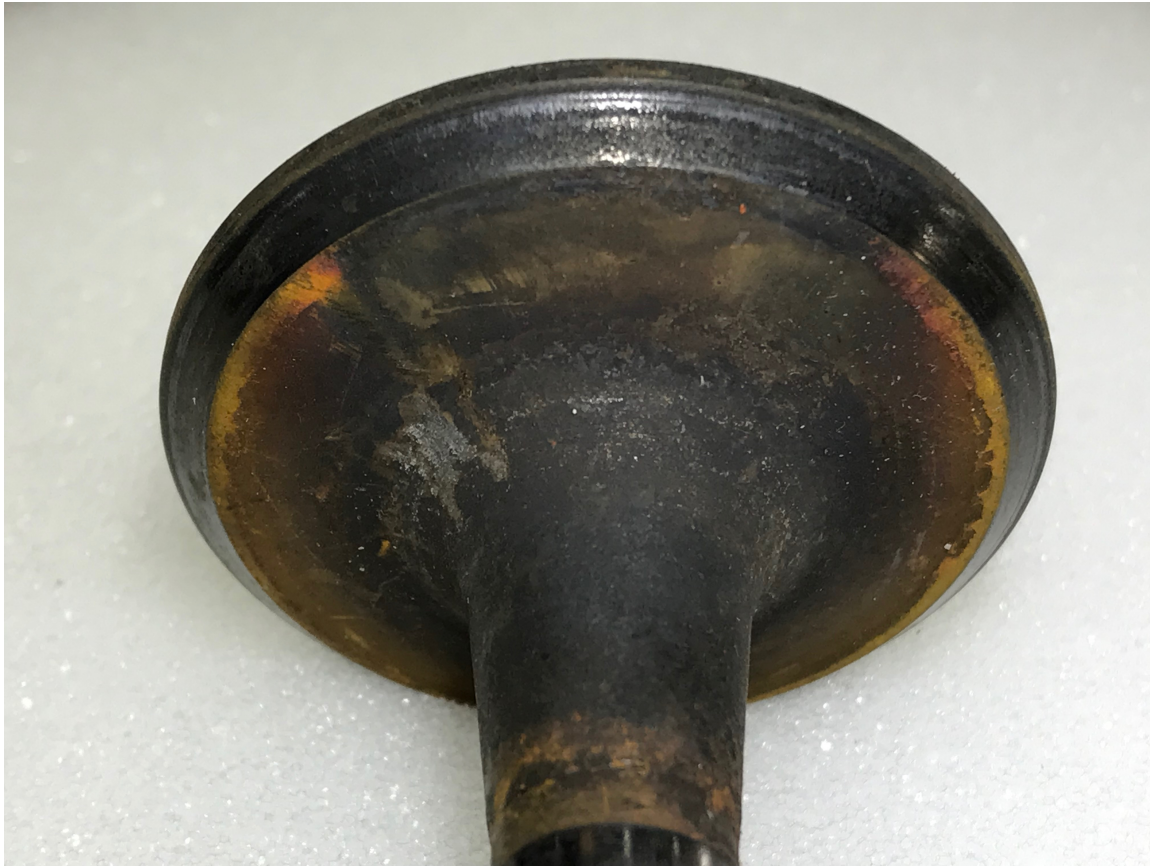
Here's the same valve... notice the rough edge at the top where it was not sealing well, and the corresponding lack of orange-ish

color, that does not continue from about 10:30 to 1:30 o'clock. The orange-ish color is likely missing from the top edge because the hot exhaust gases have burned it off that area as they escaped around the edge of the valve.

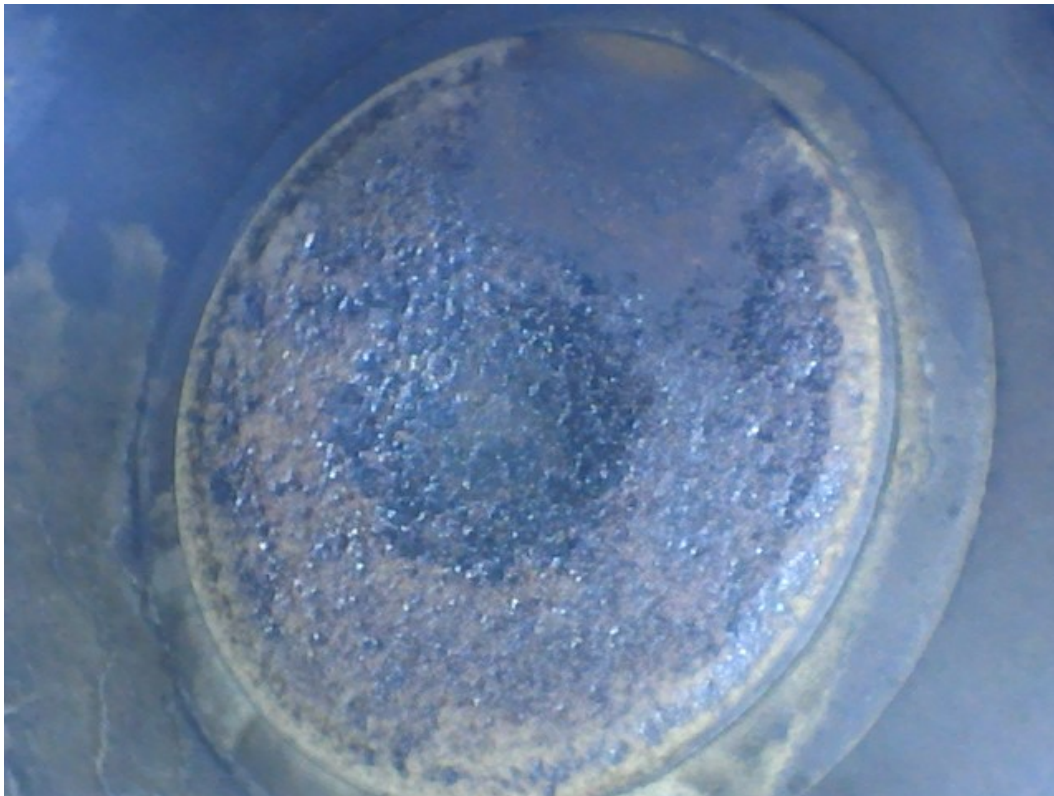
The borescope inspection showed signs that two of the four exhaust valves were headed for trouble. Here's the first one:

The upper right side of this valve (about 12 to 1 o'clock) shows a small hot spot, and the normal deposits have been burned off the surface.

With these cylinders, we discussed the options, and almost removed both of them for repair. And then we changed course, and chose the less-invasive option - **lapping the valves with the cylinders in place**. This whole topic deserves a whole separate tutorial of its own, but let's just say this is a really good option if the conditions are right. You might call it "laparoscopic surgery" instead of traditional surgery.

In this case, with the Diamond DA40 engine, we were able to lap these two exhaust valves with significant success.

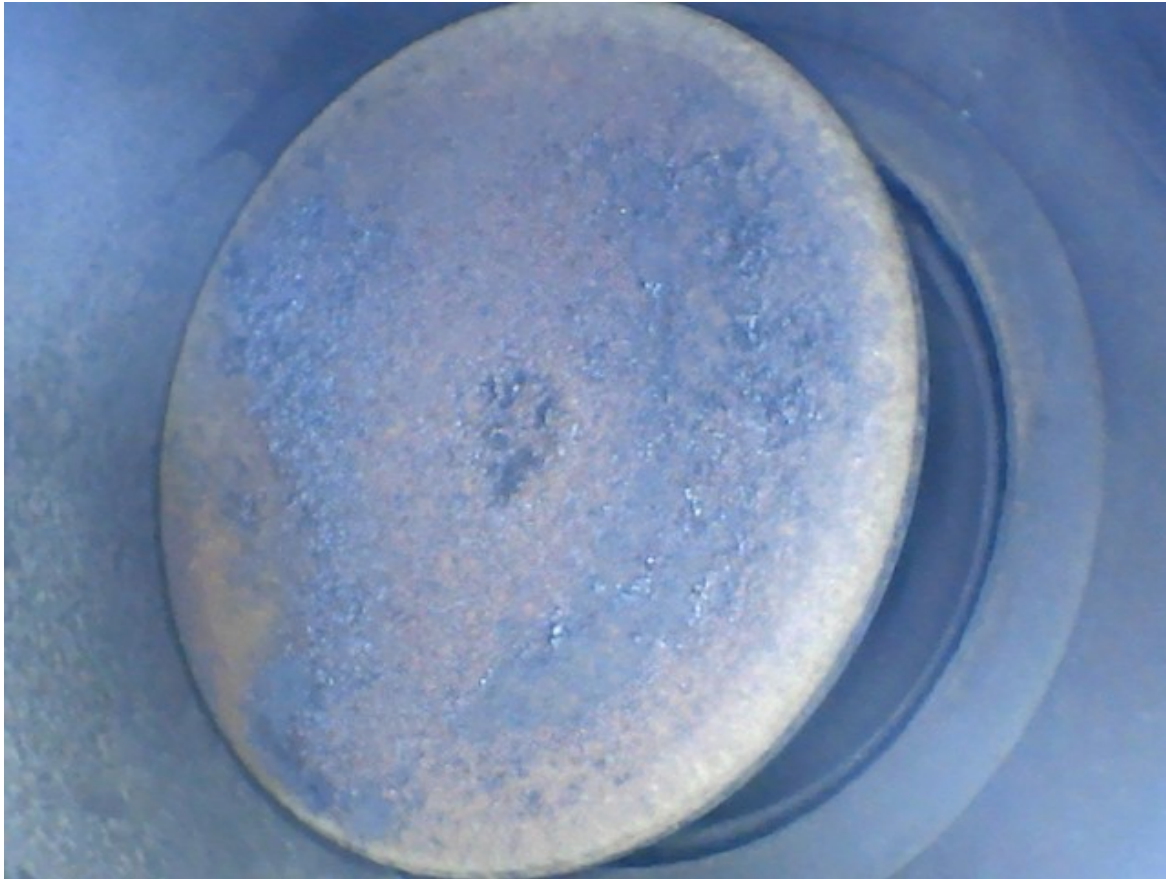
Notice the very small hot spot to the left from about 8 to 9:30. Also notice the distinct band of shiny area on the valve seat. It's consistent, but a little thin. I should have gotten a picture of the seat area over on the burning side.

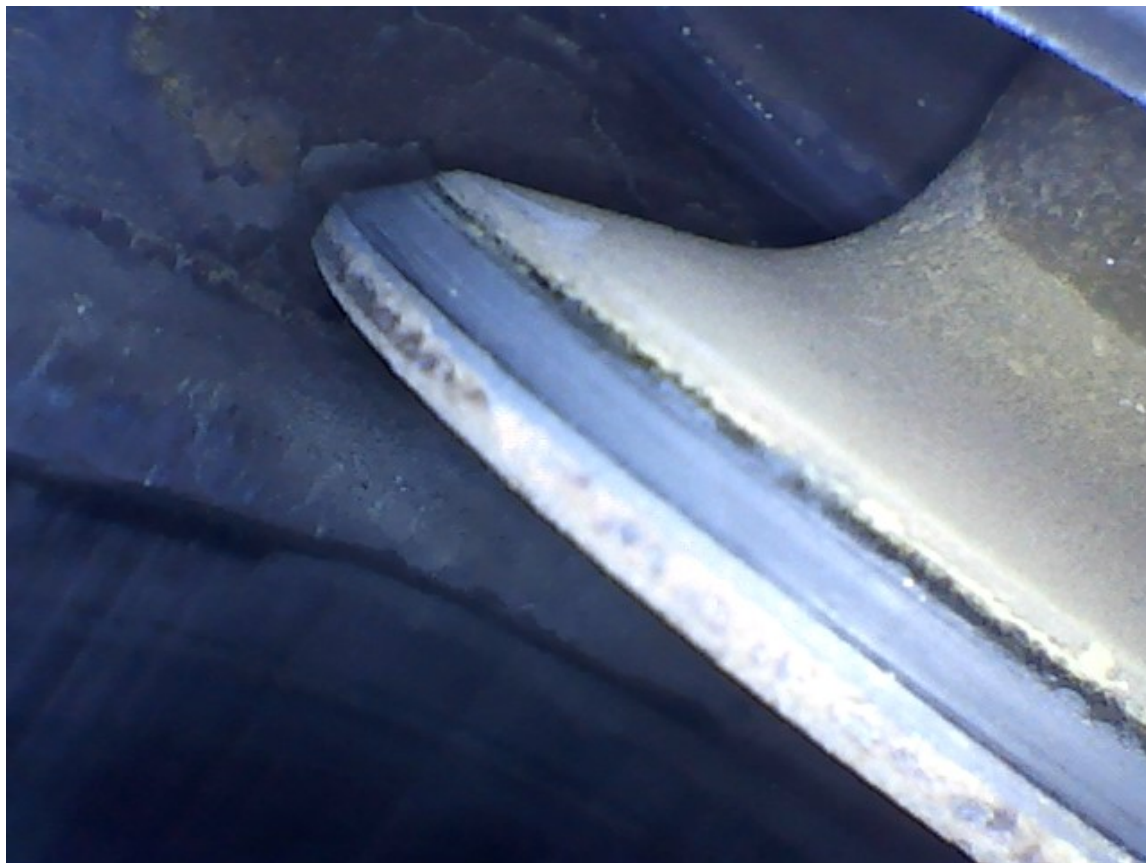
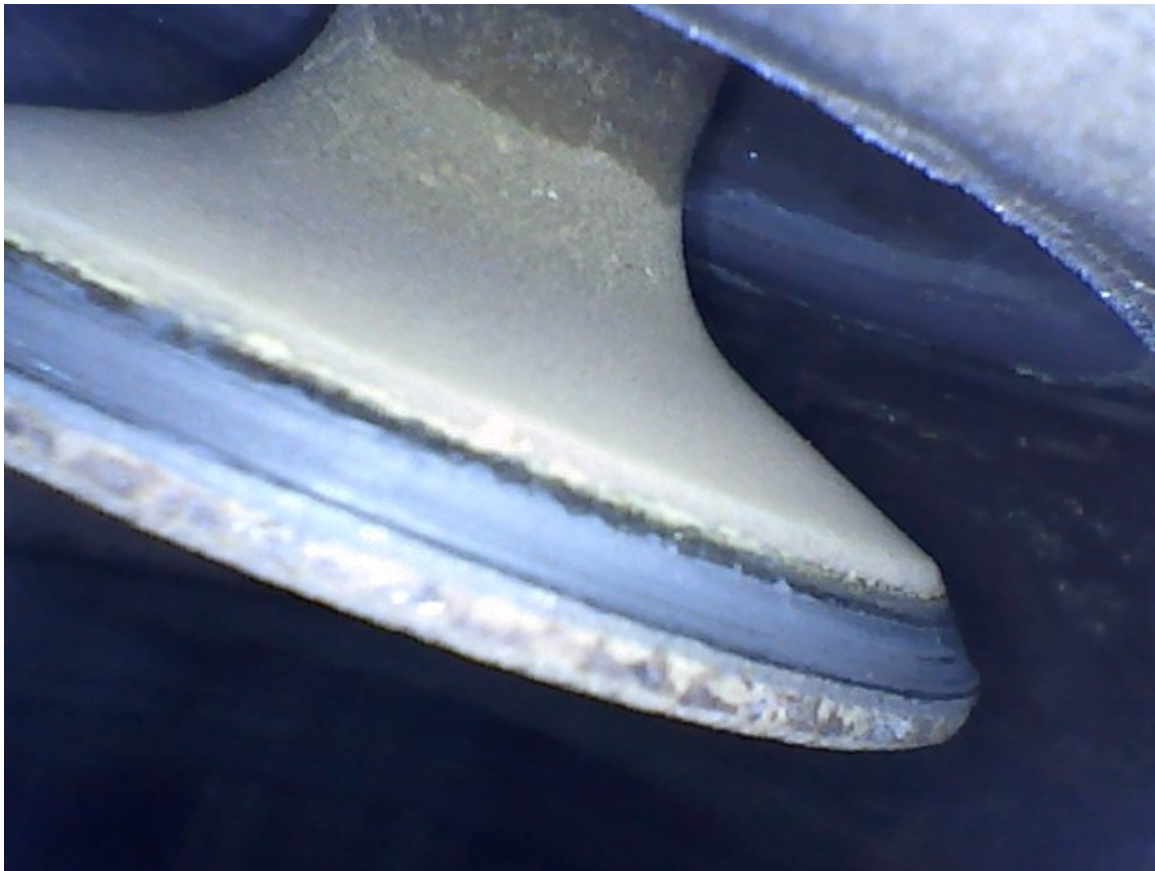
Notice the improvement of the seating area after lapping:

The valve grinding compound has restored a uniform band of sealing area both to the valve, and to the valve seat. It's hazy now, but over time as the engine runs, we're hopeful, a good, shiny seat will develop.

Both compressions improved remarkably, even with a cold compression test, immediately after the lapping procedure.

This procedure saved a significant amount of time and expense, and will hopefully extend the life of these two cylinders. This is a great option if a potential burning exhaust valve is detected early.

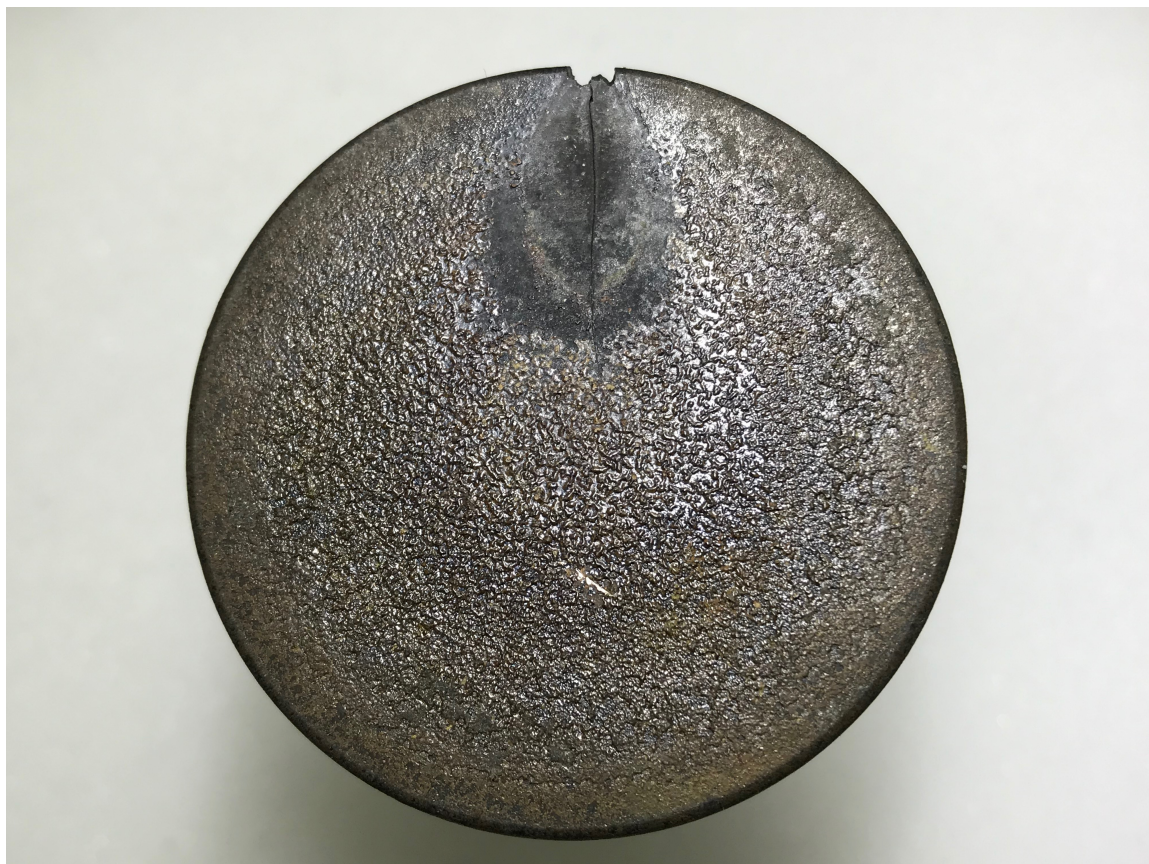
Keep in mind, the compression test on this cylinder was 61/80 and it only had 470 hours since cylinder overhaul!

(This picture was taken after removing the cylinder.)

Quite honestly, this shocked me when I saw it. I’ve looked at hundreds of exhaust valves, and I’ve never seen anything like this before. But one thing is for sure:

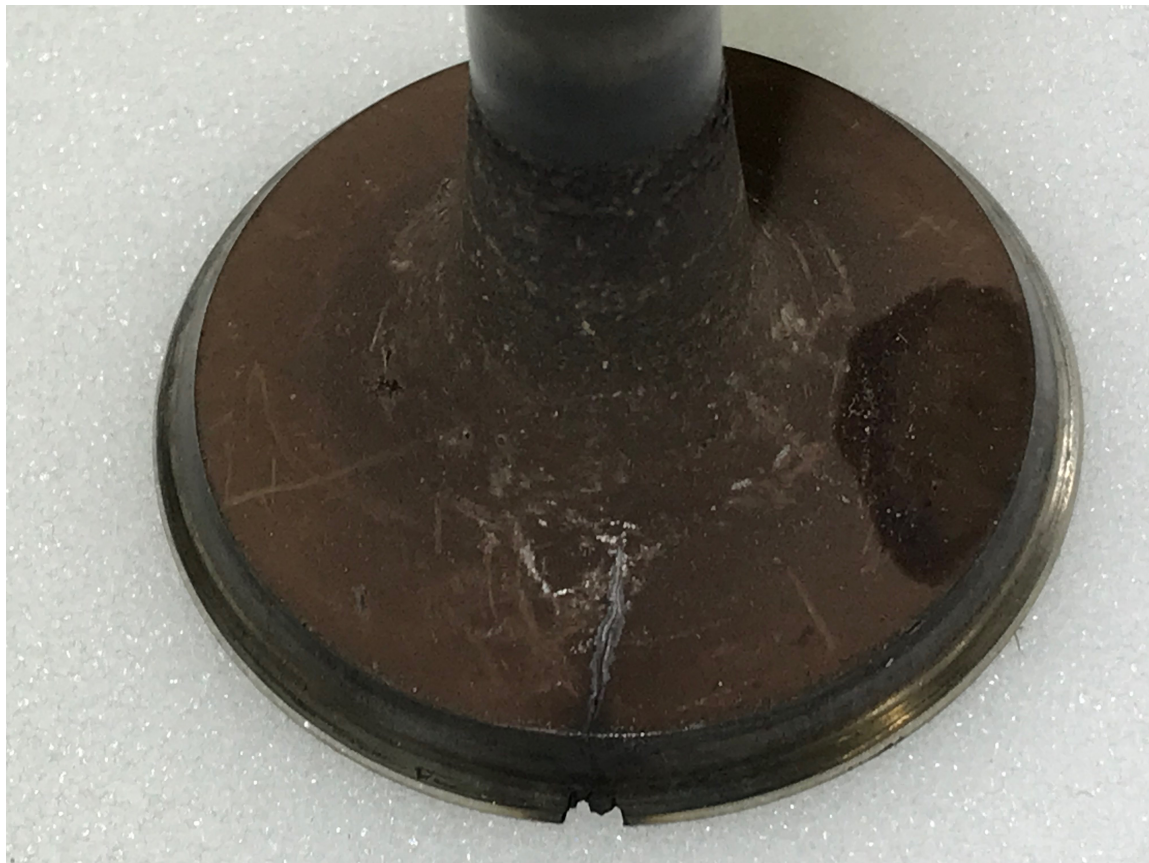
The previous picture shows how it was able to produce a compression test of 61/80... even though there is a chunk missing from the edge of the valve, there is still enough seating area left to make a seal.

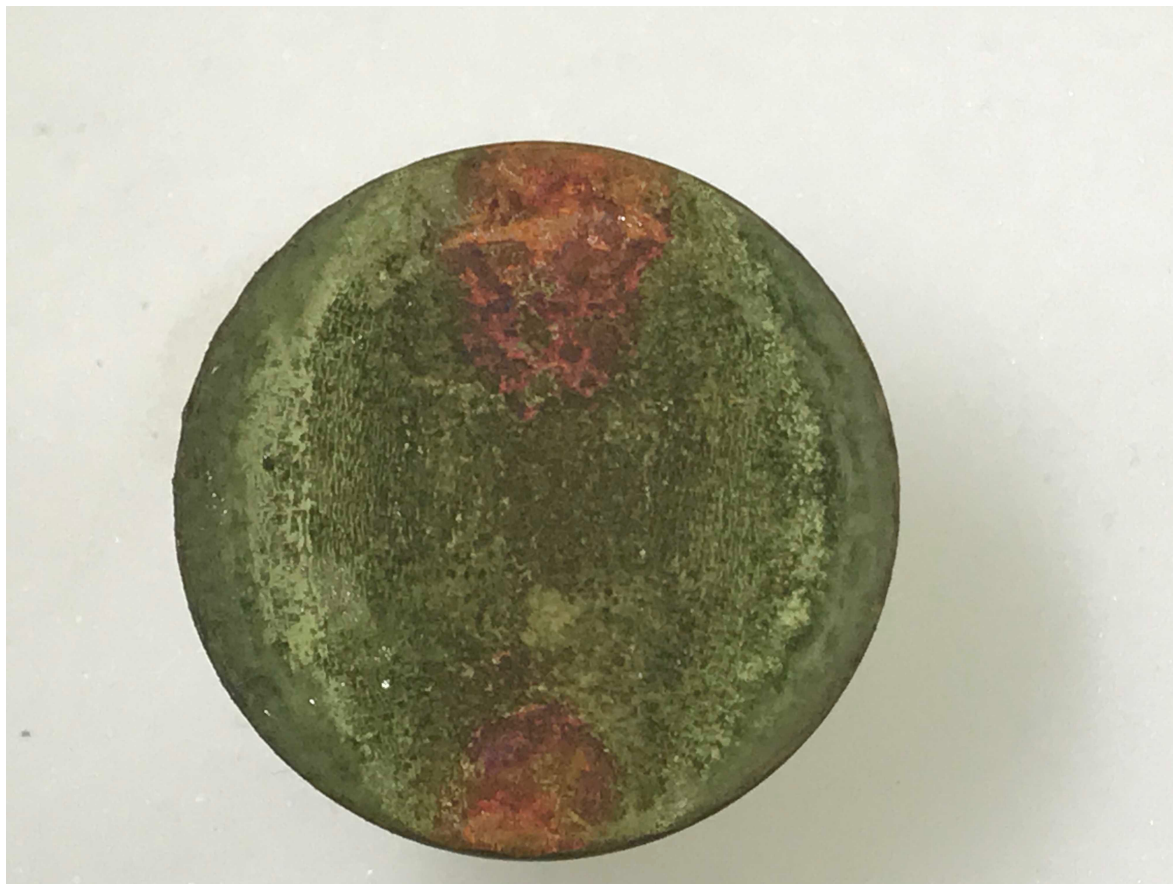
One year, when he brought his 182 to Classic Aviation for the annual inspection, one of the cylinders had little to no compression. It quickly became obvious why. Here's the exhaust valve from that cylinder:

This valve was in serious trouble! Almost the whole surface is turning green. The only healthy looking portions are the two orange-red areas at the top and bottom.

Notice the scalloped looking edge at the left... big problem.

Also notice the vertical stress lines inboard of the angled green lines near the left and right sides. Who knows how long this one would have lasted until a large chunk broke off, rendering that cylinder useless in flight.

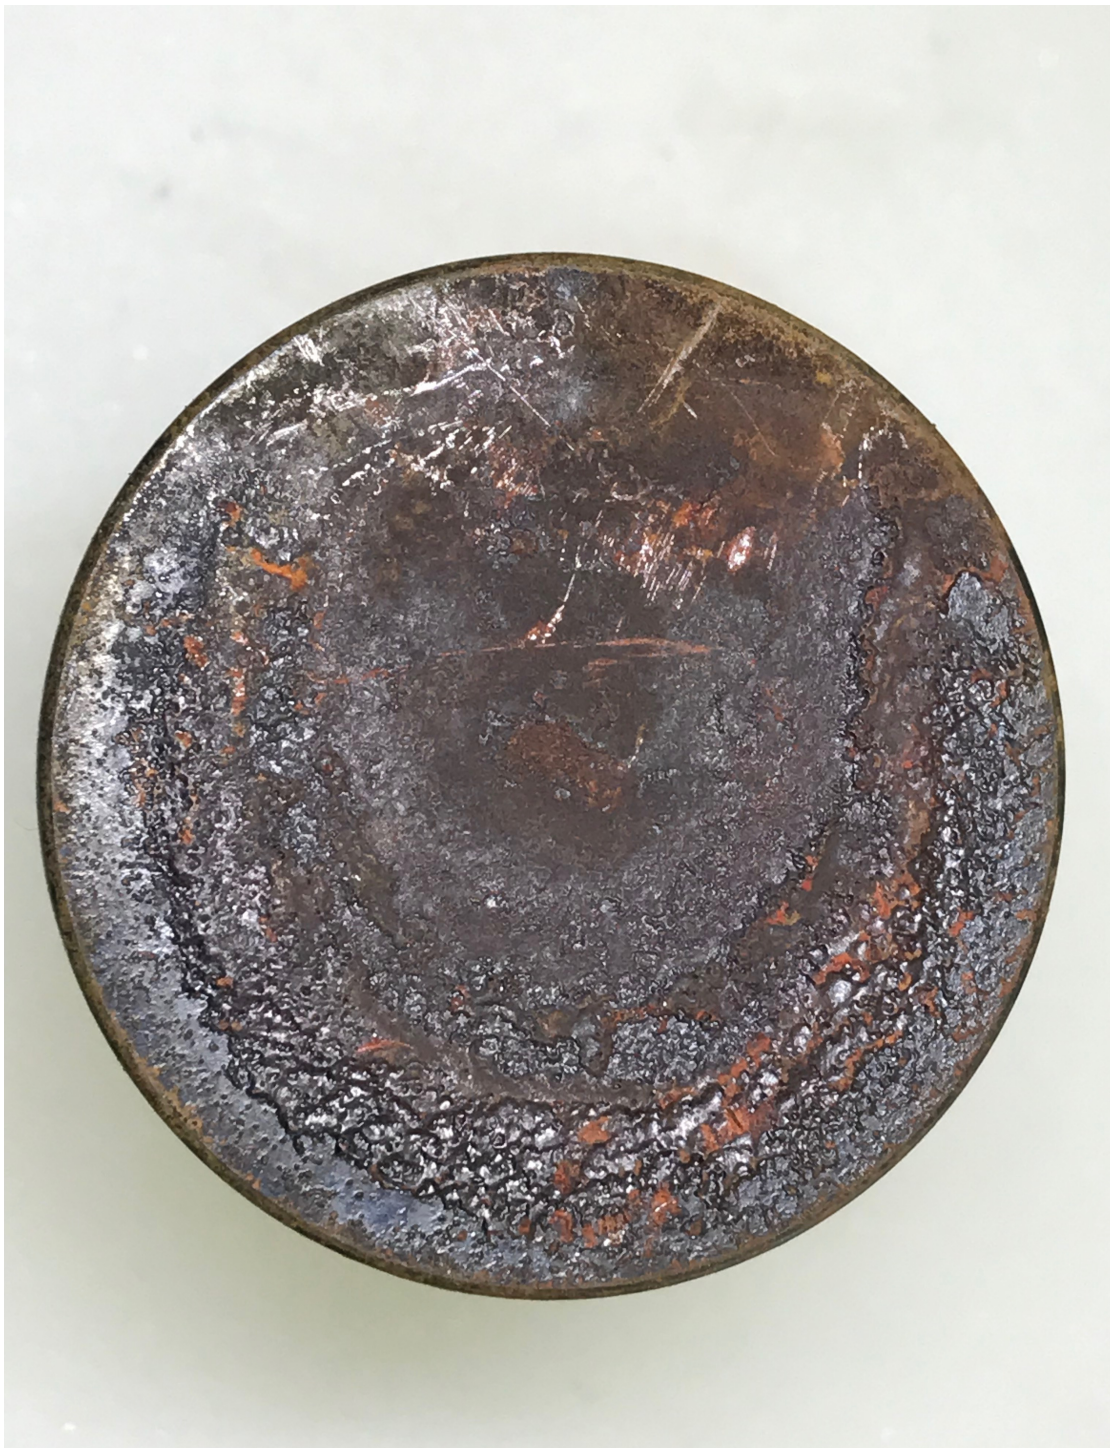
In my experience, this next valve seems to be a typical indication that is seen when an exhaust valve is burning, (or not sealing well such that the hot exhaust gases are flowing around the edge, burning off the normal deposits that are found on the valve surface.)

The trouble on this valve is at about 1 o'clock. Notice the smooth brownish area near the edge. The surface is smooth due to the deposits being burned off in that area.

Perhaps this one could be a candidate for lapping, but that would need to be evaluated by the specific A&P or IA who needs to make the decision.

Also, if the decision is made to lap an exhaust valve without removing the cylinder, it is important to follow up at regular intervals with further borescope inspections and compression testing.

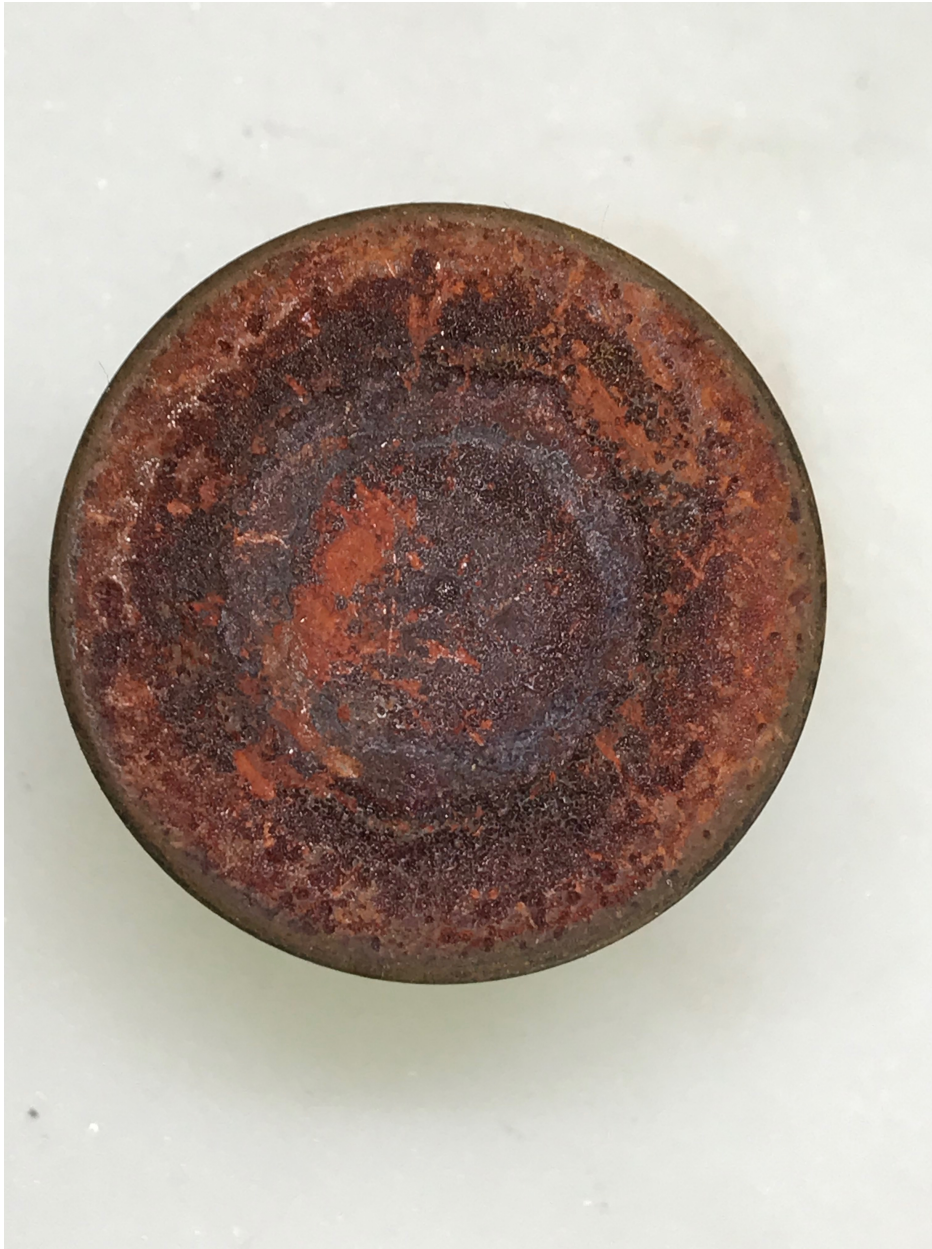
This is what you should hope to see when you look at your exhaust valves with a borescope. The reddish color is not a problem at all, and is totally normal. The concentric ring of deposits is an indication that all is well with this valve.

Keep in mind that some healthy exhaust valves will have even more deposits than this one. As long as they are consistent and in a circular pattern, it is not a problem.
